Errata No. X42A-P-001-01

Device: S1D13700F00A100

The following problems exist for the S1D13700F00A100. This document outlines the problems and provides possible work-arounds.

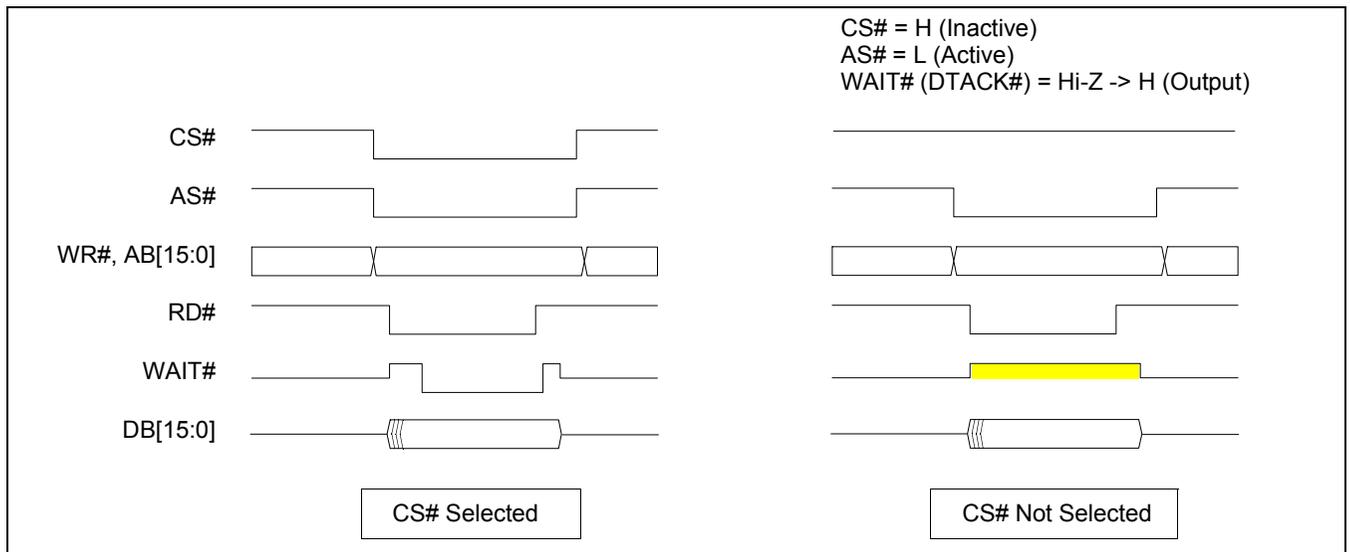
WAIT# (DTACK#) is a tri-state output pin. When CS# is not selected, the S1D13700 should place the WAIT# pin in a Hi-Z state. However, the S1D13700F00100 drives the WAIT# pin to the H level as shown by the yellow colored pulse in the following chart.

A possible work-around for the problem is to make an additional circuit on the system board. Add an OR gate circuit to system board as shown in the following diagrams. When this OR gate is added to the S1D13700 AS# input, the S1D13700 remains in a high impedance state for WAIT# (DTACK#) output even when CS# is not selected.

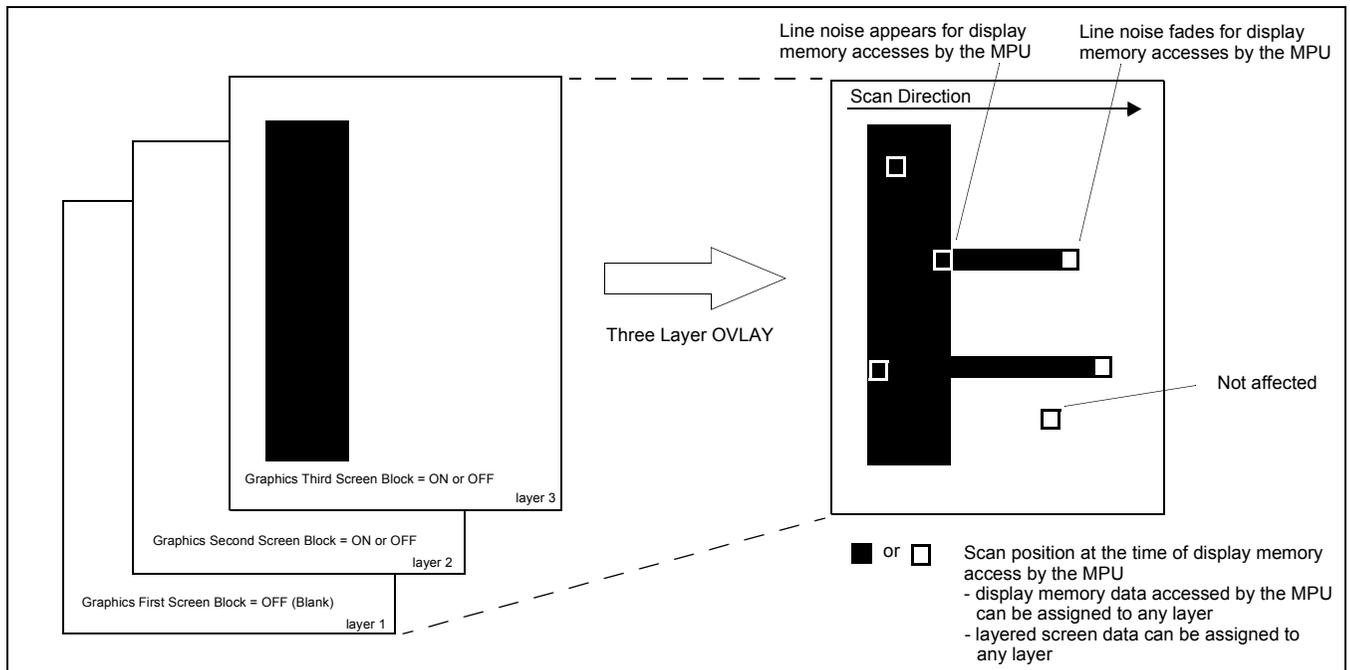
When overlaying three layers, the S1D13700 scans display memory data line by line and then displays it. If the display memory is accessed by the MPU while the S1D13700 is scanning, data shown on the display is fixed to the data scanned. If access to the display memory does not continue, the display state returns to normal from the next frame onward.

The following diagram shows how the problem appears on the display. Random line noise appears to the right of the black and white border, only while the MPU is accessing the display memory.

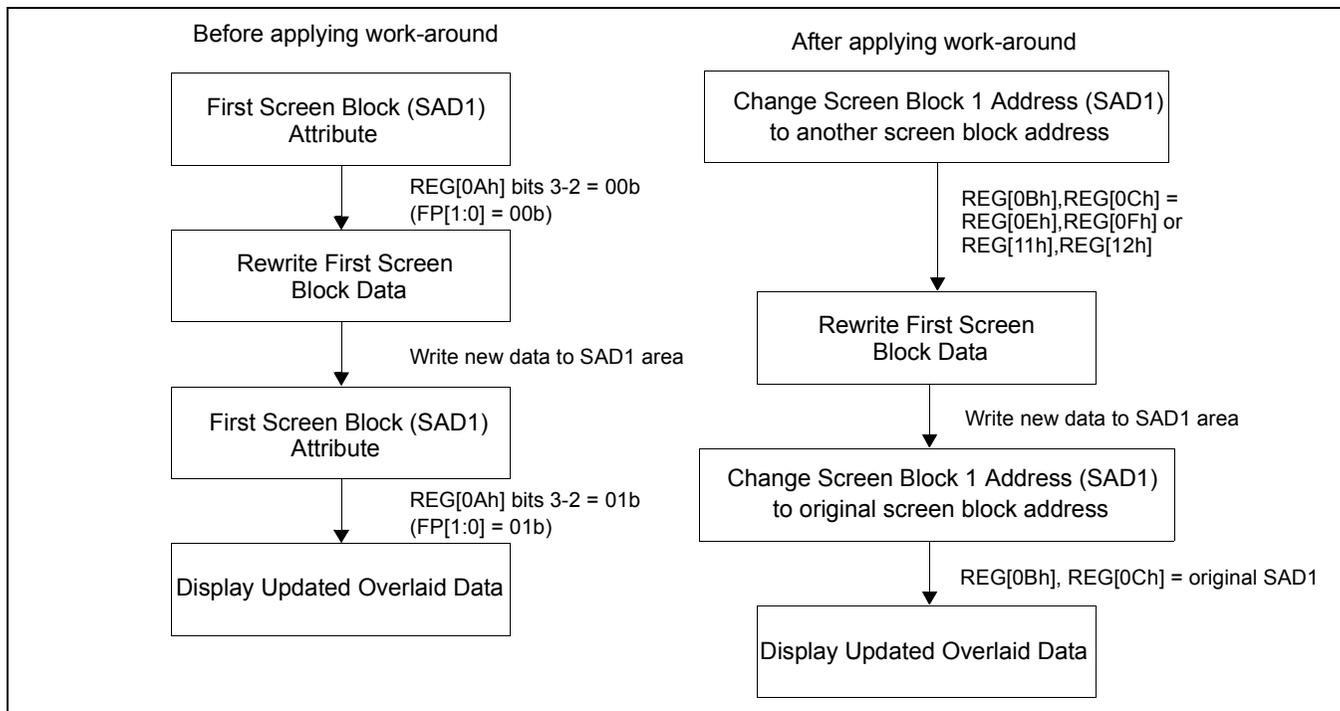
The flow on the left sets first screen block attribute to “off”, accesses the display memory, and then returns the attribute to “on”. This flow will allow the problem to occur.

There is a software work-around for this problem. The following flowchart shows two example flows. The flow on the left does not use the work-around and will cause the problem to occur. The flow on the right demonstrates the work-around and will avoid the line noise problem.

The flow on the right changes the first screen block address to the same value as another screen block address instead of setting the attribute to “off”. This causes the first layer not to be displayed while the display memory is being updated by the MPU. Once the display memory update is complete, the screen block address can be returned to the original address. This flow avoids the line noise problem.
